Manhole Inspection Summary

Manhole # S35MM_040MH

Insp Date: **3/8/07 11:31 AM**

Location Address: **200 20TH ST**

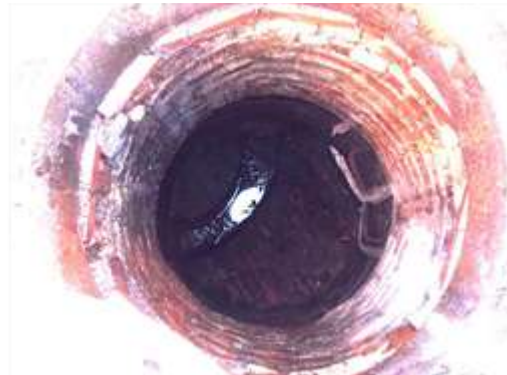
Top View

Corroded and missing steps. Bench debris.

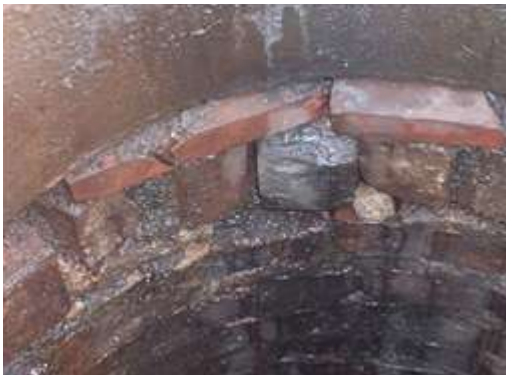
Defect

Frame Offset: **0** (in.) Condition: ☐ Sound ☐ Cracked ☒ **Leaks**

Condition: ☐ Sound ☐ Cracked ☐ Root Intrusion ☒ **Loose Brick** ☒ **Deteriorated**

Infiltration: ☐ None ☒ **Joint** ☐ Cracks ☐ Mortar ☐ Roots ☒ **Wall**

Frame leaks. Adjustment deterioration, loose brick and infiltration.

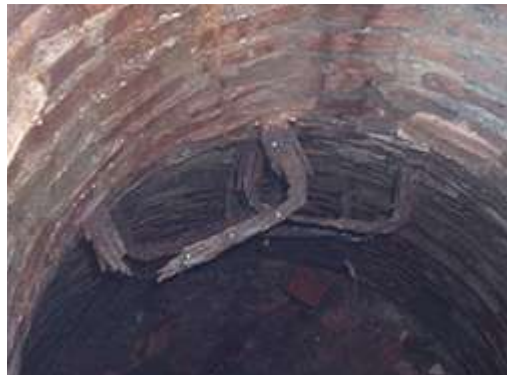
Defect

Infiltration: ☐ None ☐ Joint ☐ Cracks ☐ Mortar ☐ Roots ☒ **Wall**

Barrel infiltration.

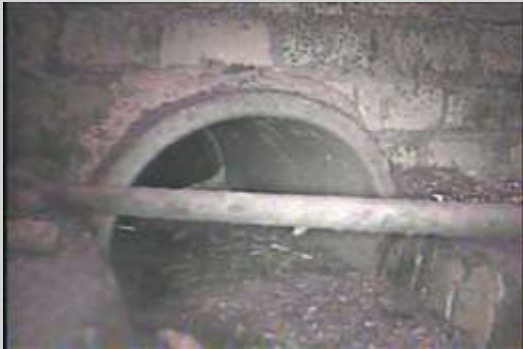
10 in. Circular Gravity Sewer Pipe Out @ 12 O'Clock

Deposits: ☐ None ☒ **Mud** ☐ Sludge ☒ **Debris** ☐ Grease

Silt Depth: **2** (in.) Deposits Extent: **Light**

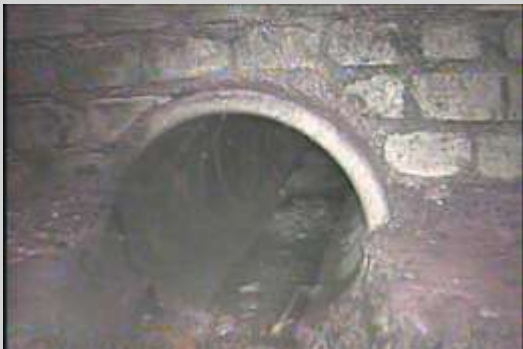
8 in. Circular Gravity Sewer Pipe In @ 9 O'Clock

Deposits: ☐ None ☒ **Mud** ☐ Sludge ☒ **Debris** ☐ Grease

Silt Depth: **0.5** (in.) Deposits Extent: **Light**
